# TECHNICAL BULLETIN

DS7, R5's, RD250, RD350

CLUTCH, Elimination of Slipping

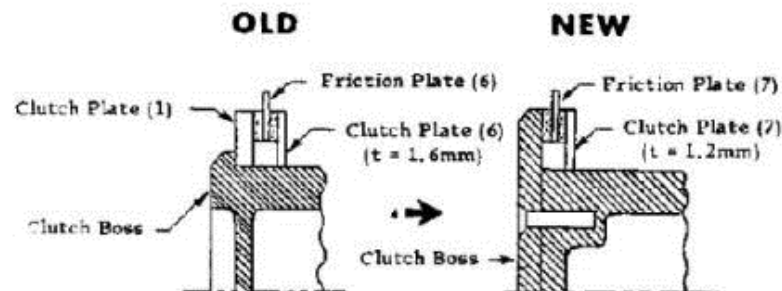
Clutch assemblies on above models have been redesigned to reduce clutch slippage. This change consists of replacing the clutch boss and clutch plates and increasing the number of friction plates from six (6) to seven (7). See table below for both old and new parts list.

The clutch must be assembled with the first friction plate against clutch boss. See drawings below.
